Example of interference situation in Estonia

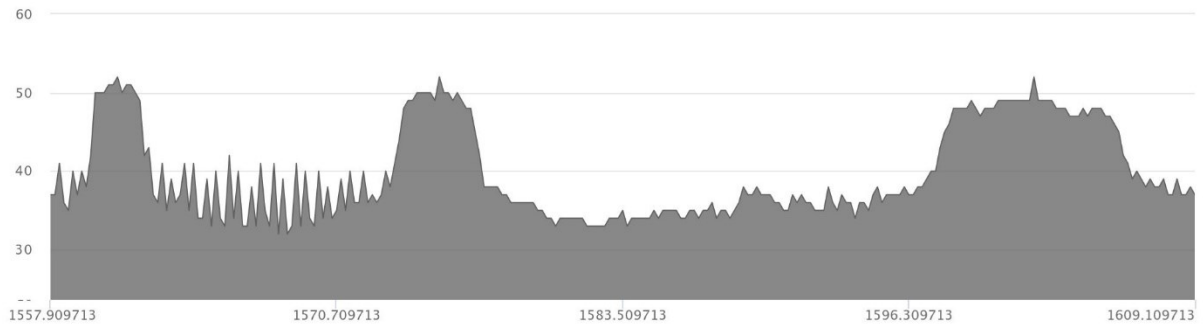
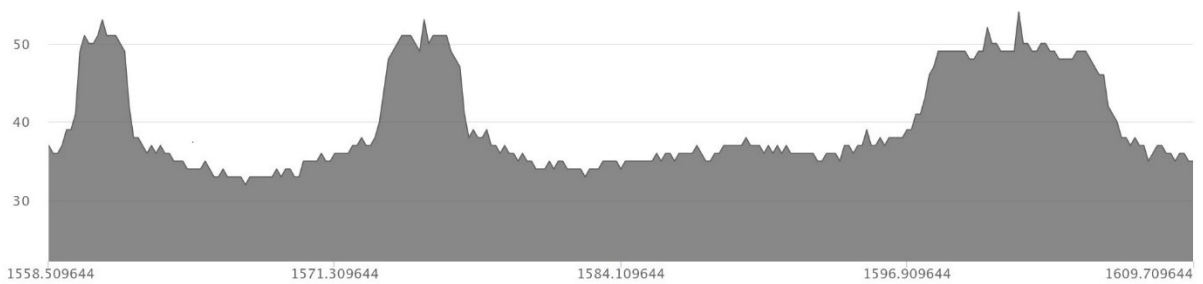
Monitoring station in Narva (59°22'50 N, 028°11'27 E) region near the border with Russian Federation detected two sources of interference with bearings 26° - 27° and 70° - 72°. The sources of interference are located in Russian Federation in Leningrad Region.

4. Spectrum screenshots of interfering signal (dBuV/m) on 08.02.2025 and 09.02.2025 respectively, center frequencies of interfering signals are 1575,4 MHz, 1561,0 MHz and 1602,0 MHz:
