TEST REPORT No. 1397-CPR-154/D.6
According EN 12566-1:2000, EN 12566-1:2000/A1:2003 Pit test

3. SAMPLE: Small wastewater treatment system (SWWTS) ST3. Material – Glass reinforced plastic (GRP).
4. SAMPLE DELIVERY DATE: 2016-03-29.
5. TESTING LOCATION, ADDRESS AND DATE:

7. IDENTIFICATION OF THE METHOD USED:
The test was made according to EN 12566-1:2000, EN 12566-1:2000/A1:2003 Small wastewater treatment systems for up to 50 PT – Part 1. Annex D clause D.6 Pit test.

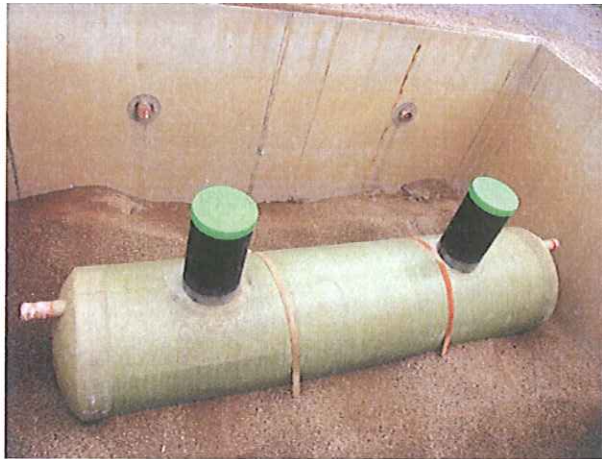
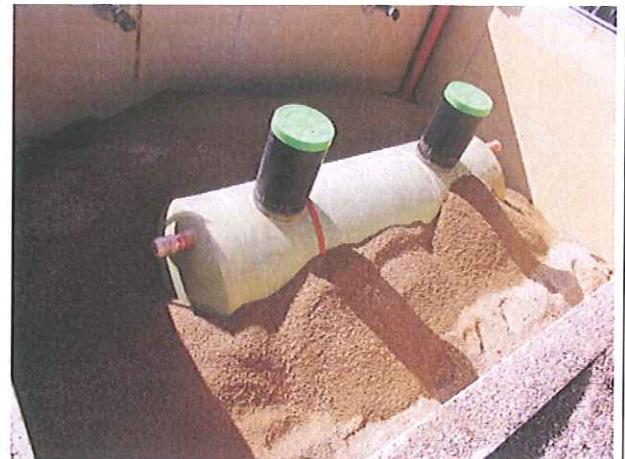
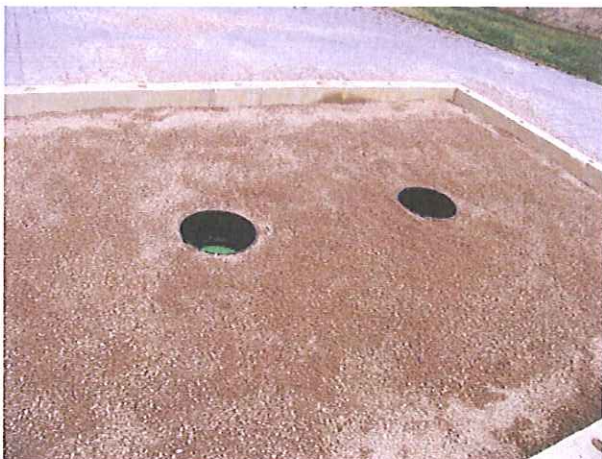
Figure 3. Photos taken during the test period

View during installation

11. OTHER INFORMATION: photos taken during the test period, Fig. 3.

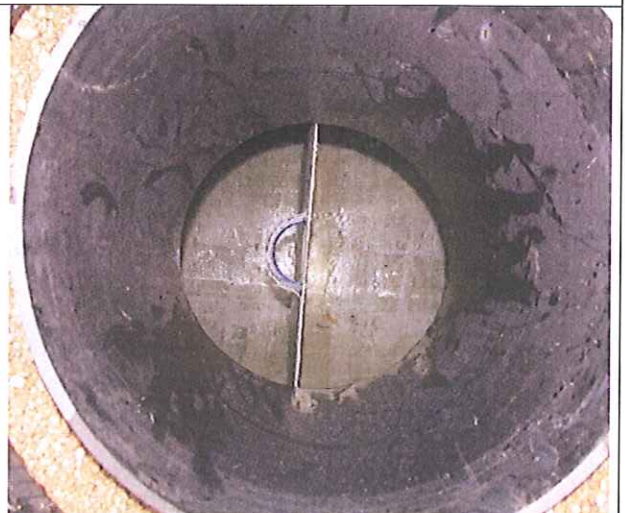
Inside view after 3 weeks.
