# Notice of Proposed Amendment 2025-01 (A)

## Take-off performance parameters and position errors — large aeroplanes

RMT.0741

WHAT THIS NPA IS ABOUT		
<p>This NPA proposes to require some large aeroplanes to be equipped with a take-off performance monitoring system (TOPMS). The proposal addresses new designs, with an amendment of the Certification Specifications and Acceptable Means of Compliance for Large Aeroplanes (CS-25), and some already approved designs when the aeroplane is still in production and operated in commercial air transport, with an amendment of Part-26 (Annex I to Regulation (EU) 2015/640) and, subsequently, of the Certification Specifications and Guidance Material for Additional Airworthiness Specifications for Operations (CS-26).</p> <p>The objective is to mitigate, using an on-board alerting system, the risk of large aeroplane accidents or incidents caused by the use of erroneous take-off performance parameters and erroneous take-off positions. Such errors have the potential to result in runway excursions and aeroplane upsets, with subsequent loss of control and collision with terrain or obstacles.</p> <p>The proposed regulatory material is expected to impro

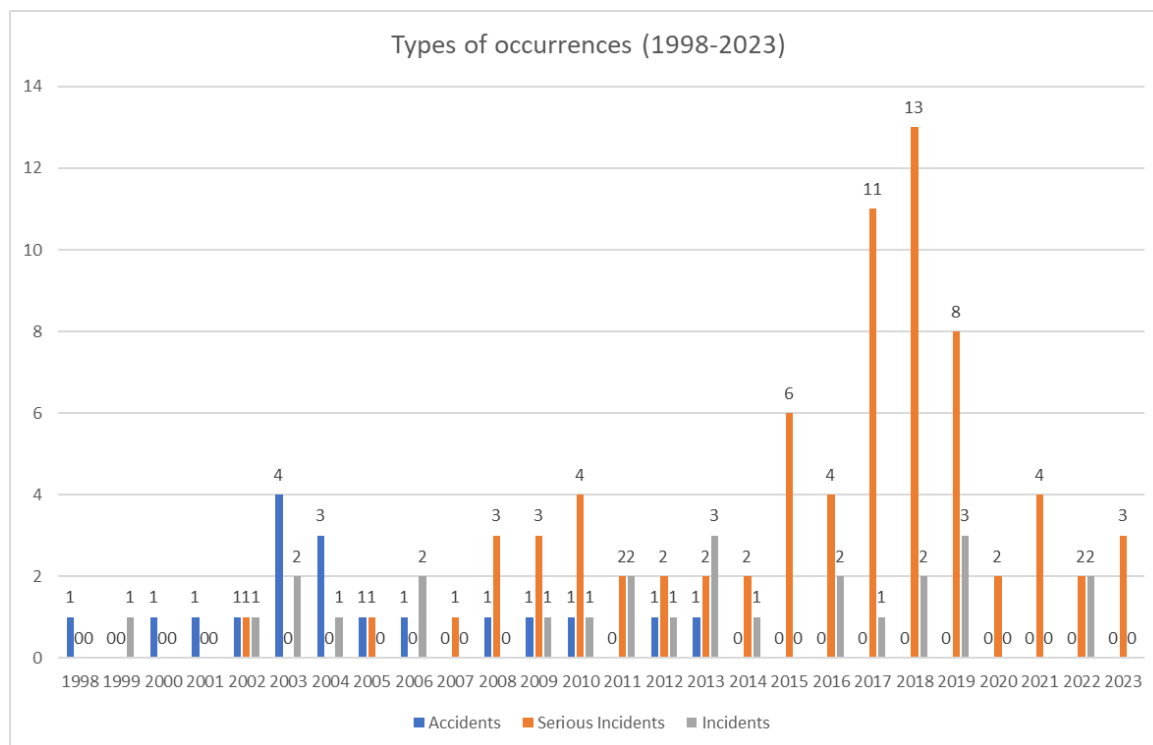
Figure 2. Yearly distribution of the reported occurrences (by type of occurrence)

The breakdown of the 118 occurrences is as follows: 18 accidents (including 5 fatal), 74 serious incidents and 26 incidents (Figure 2).
